# SNS Ring injection experience

Project X collaboration meeting,  
FNAL, Sep 10-11, 2009

M. Plum,  
Ring Area Manager

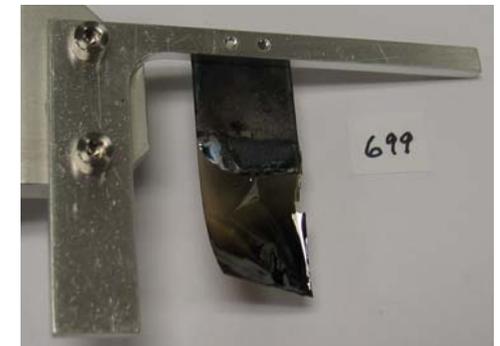
Typical foil damage before May 3

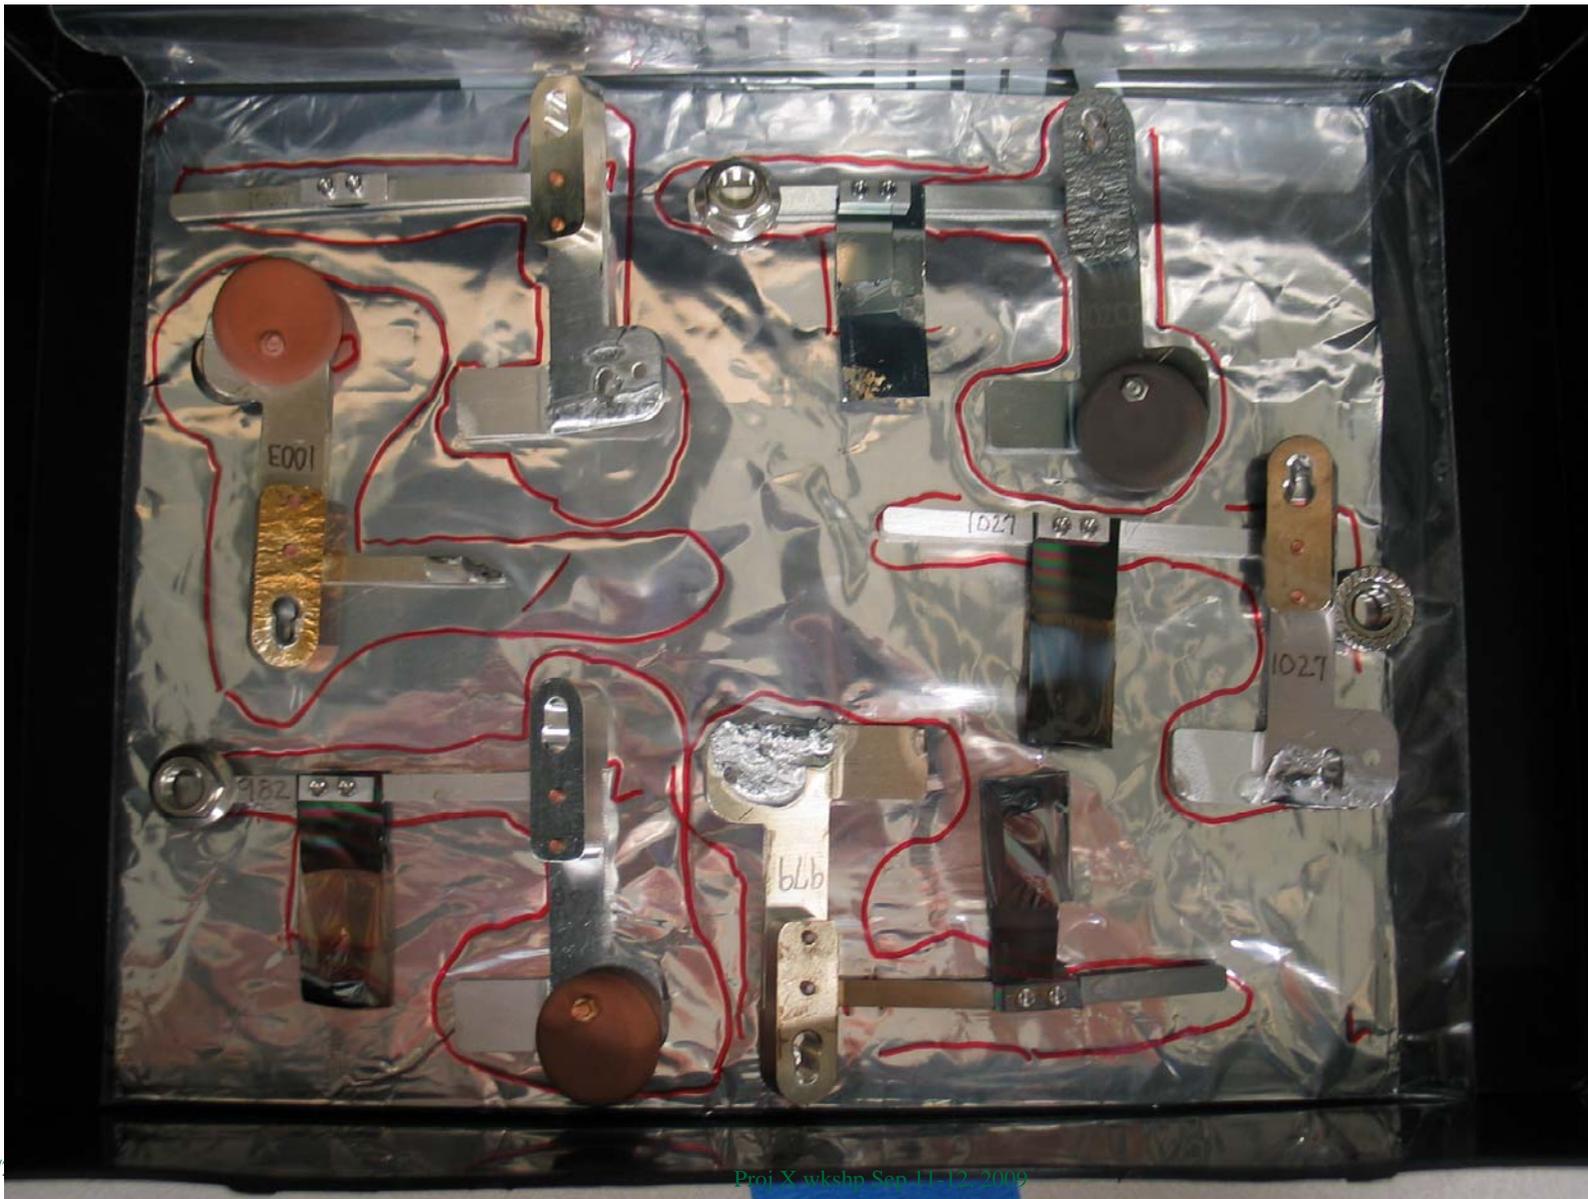
All six foils used for production beam from March to the May 19, 2009 change out

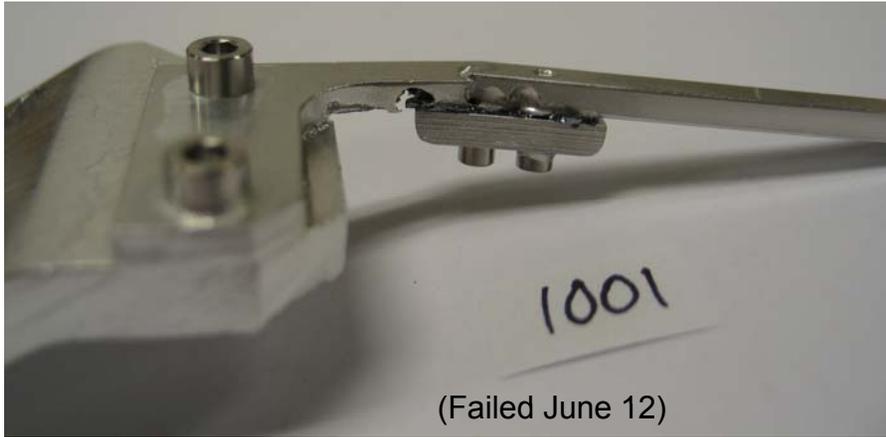
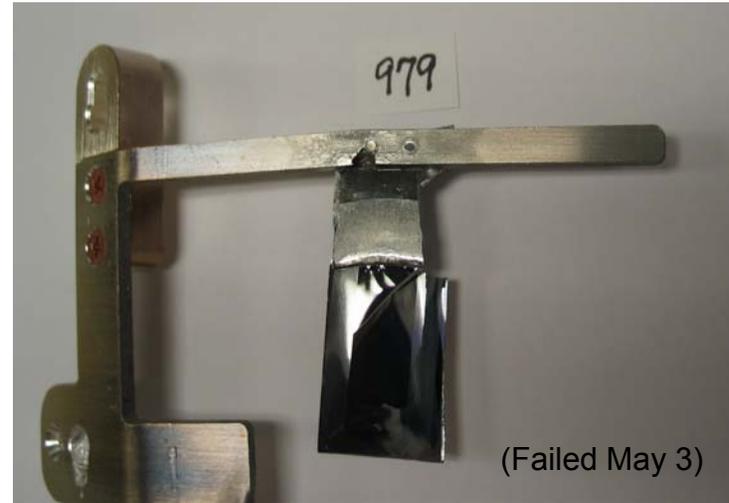
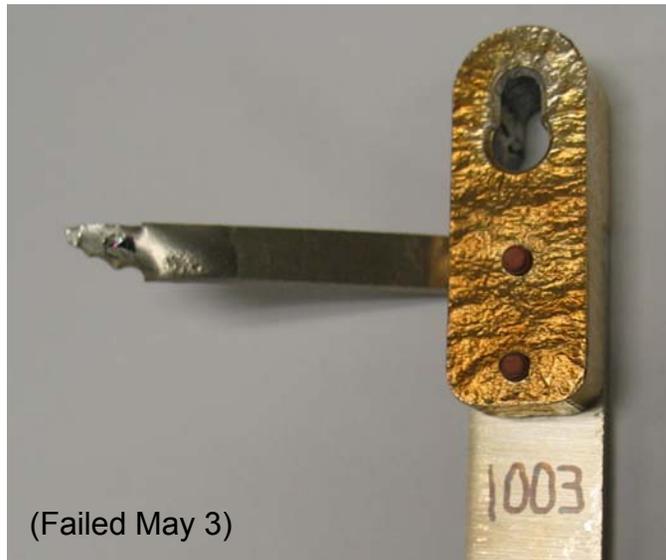
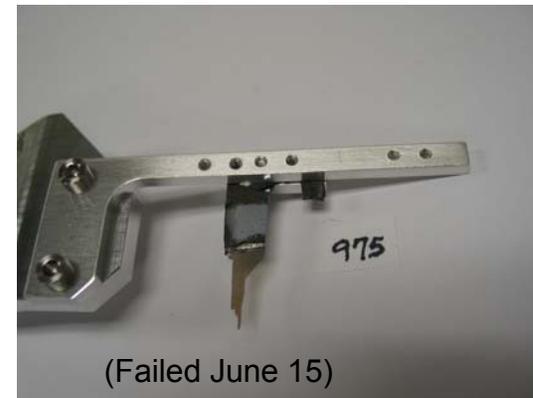
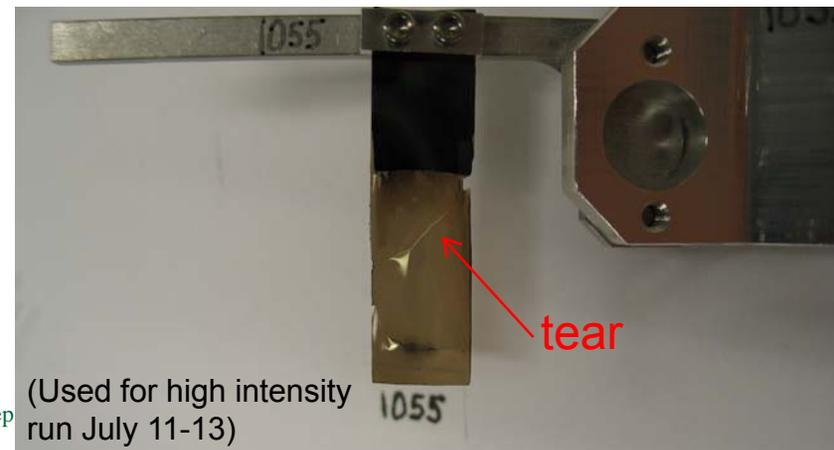
# Foil failures (cont.)

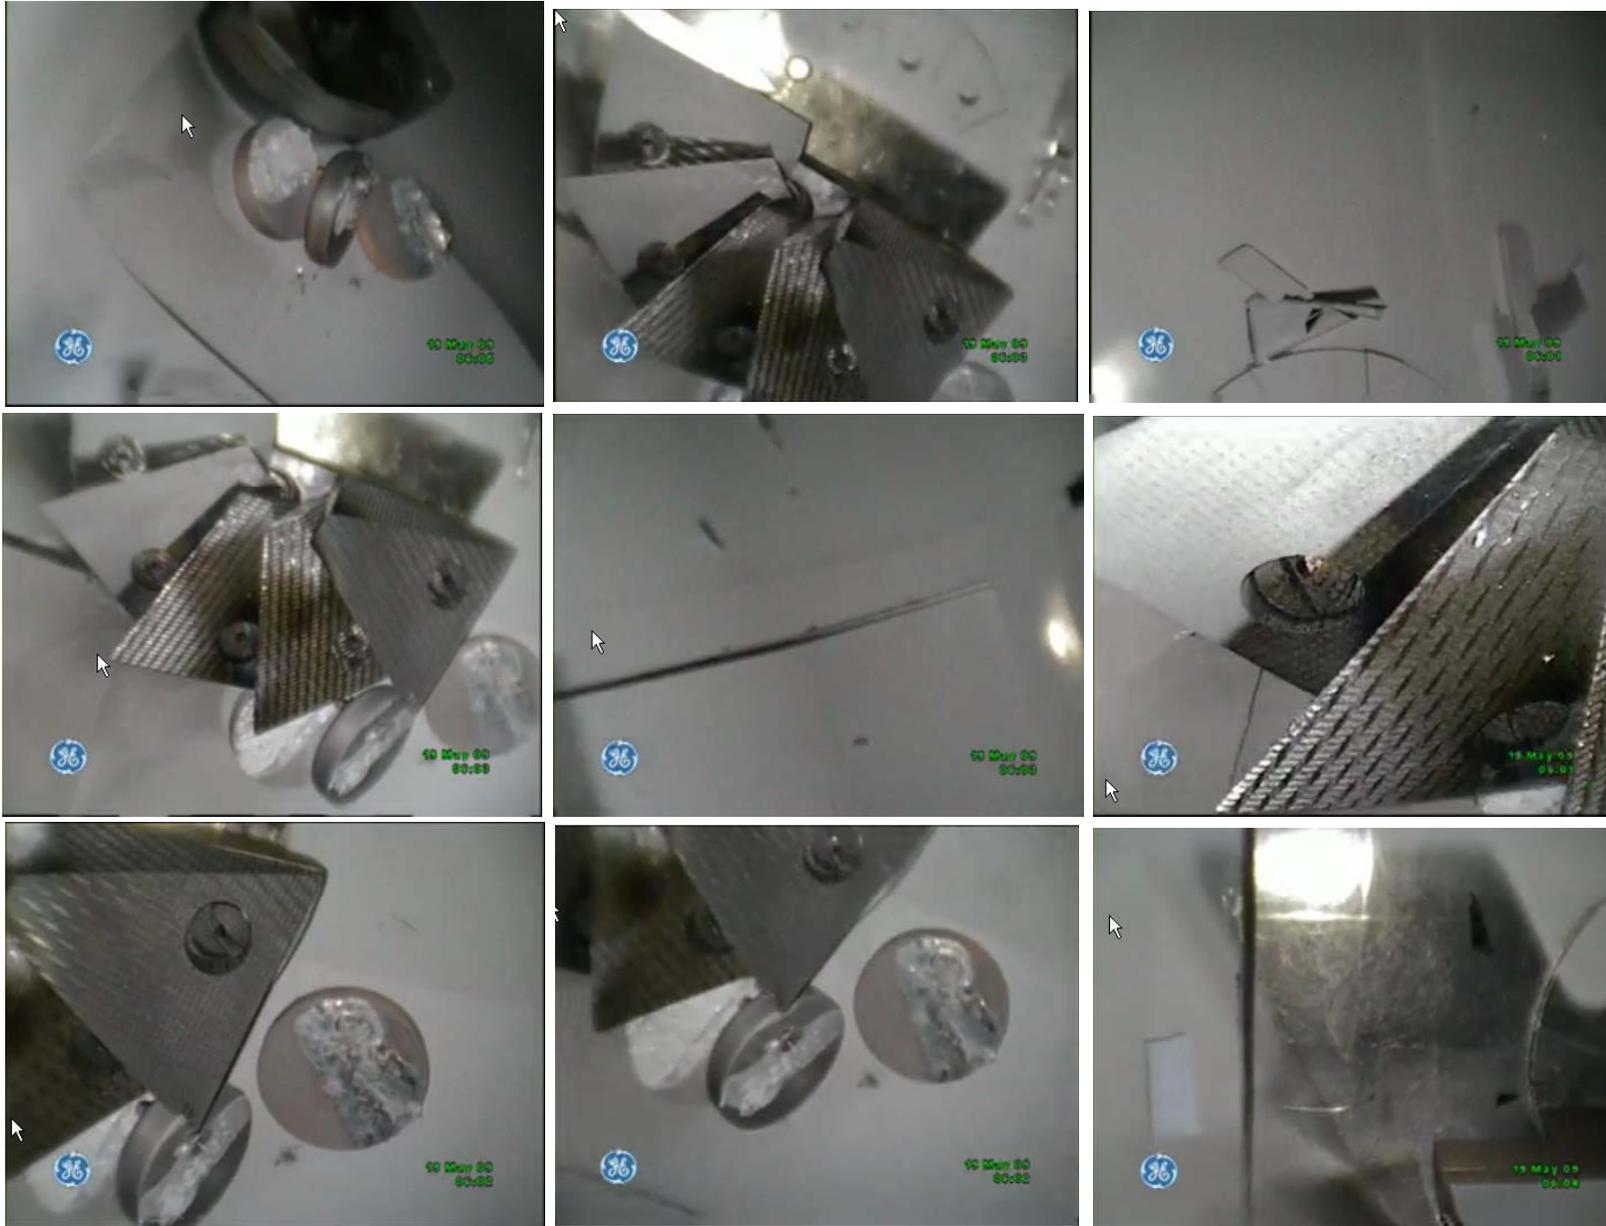
# Boroscope snapshots on 19/May/09

- Counterweights falling off
- Bracket melts where foil is attached
- Foils break where foil is attached to silicon, and where the silicon meets the bracket
- Foils have bright beam spots (and very high heating?) for a few weeks following May 3.
- Material deposited / evaporated on foils, brackets, and other nearby components
- Foil brackets stick to the pin they hang from
- Some foils have much higher A13b losses
- Foil corner curls up after a while

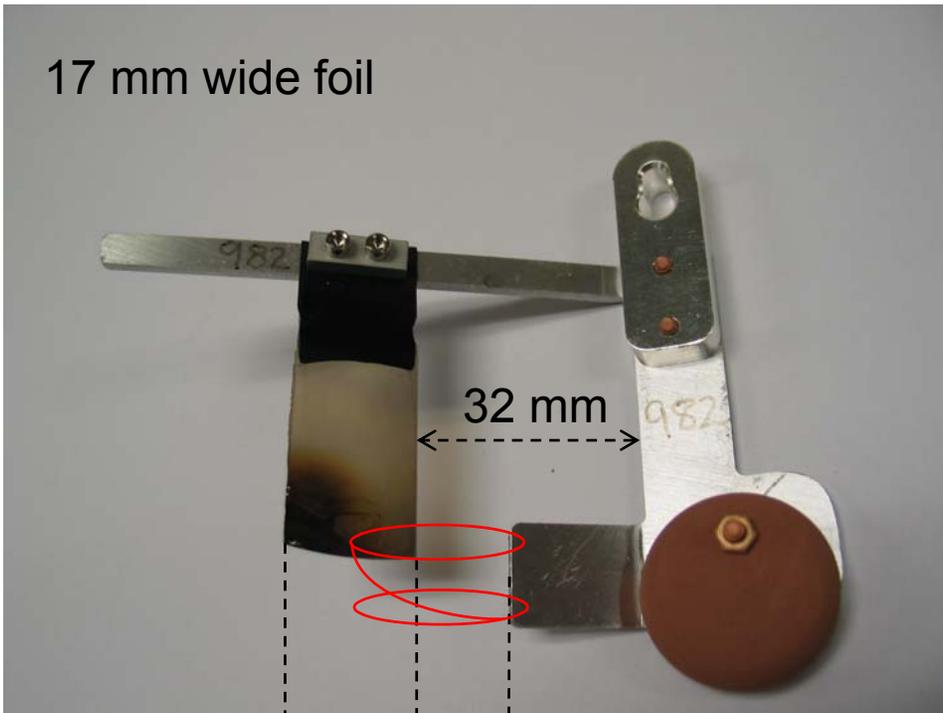
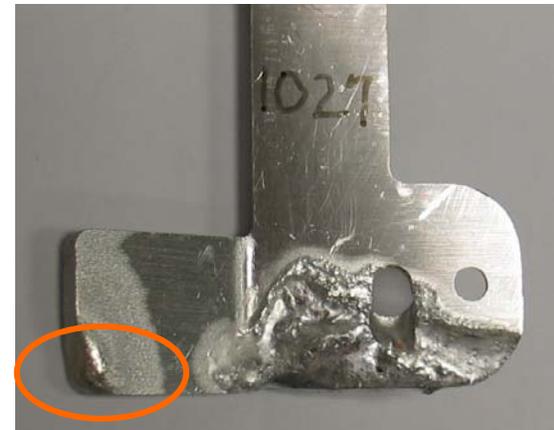
# Convoy electrons hitting bracket

12 mm gyroradius electron

Melting points  
Aluminum = 660 °C

Foils should be mounted >24 mm horizontally from the bracket. All new foils will be mounted at the “+1 cm” position. Also helps to use high temperature material for brackets.

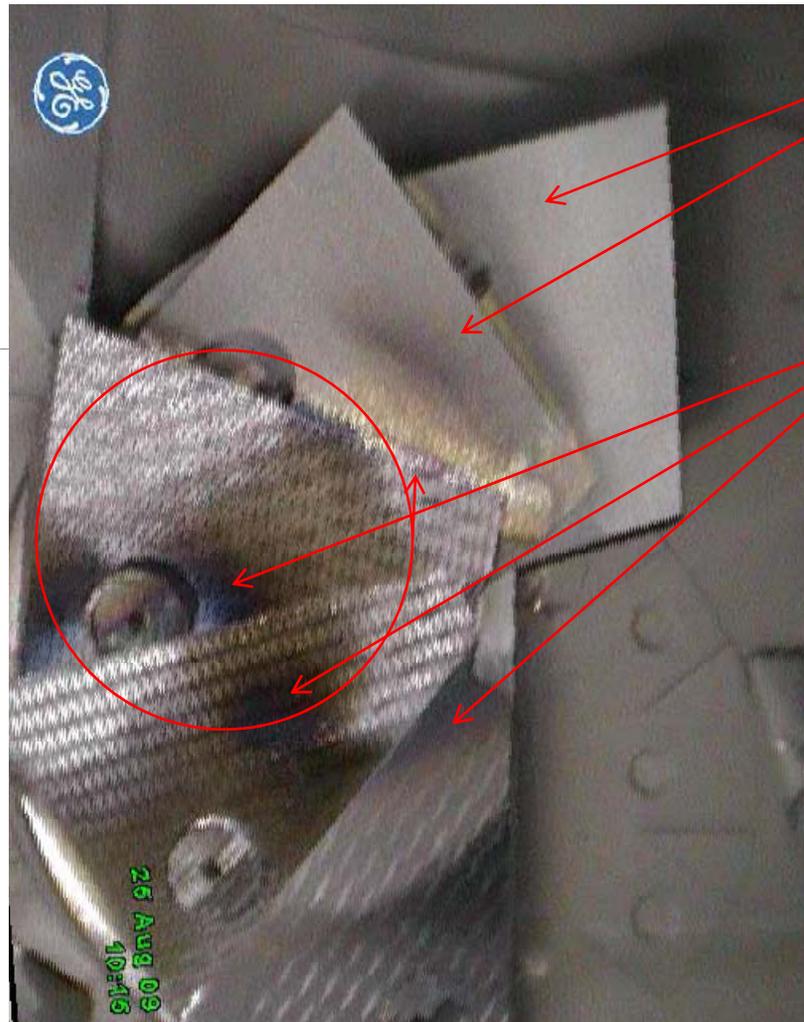
- The position of the electron catcher in the installation drawings may not be correct, and the as-built vacuum chamber cannot be positioned according to the installation drawings (prelim. #'s:  $\Delta x = 7$  mm,  $\Delta z = 11$  mm)
- The position of the injected  $H^-$  beam was shifted  $\sim 8$  mm beam left to accommodate problems in the injection dump transport
- This causes the convoy electrons to hit the top surfaces of the carbon-carbon electron catcher blocks
- Interior surfaces of the vacuum chamber were coated with Al due to the bracket melting problems
- All of the above contributes to convoy electrons reflecting off the electron catcher, rather than being absorbed by the catcher
- The electrons continue their counter-clockwise motion and spiral back upward

# Convoy electron footprint (cont.)

Al coating

Electron impact

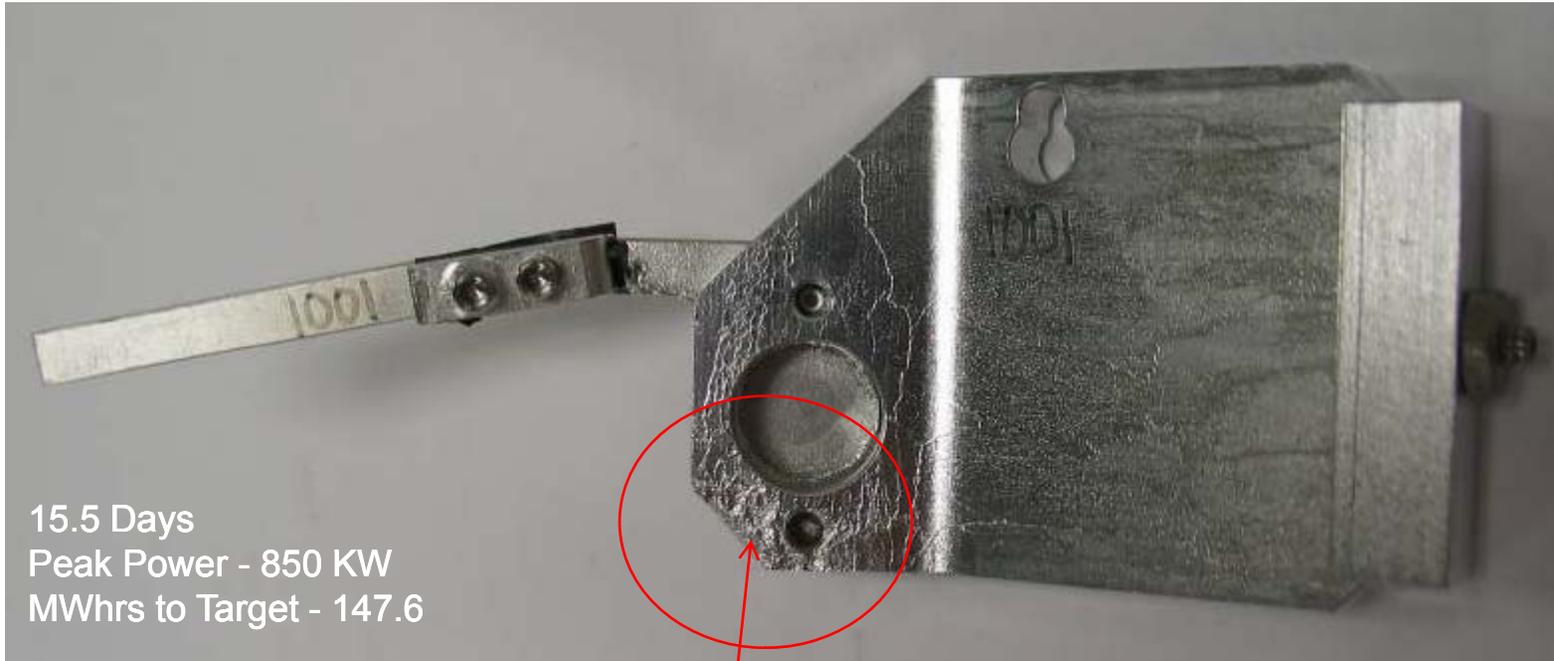
# Bracket damage by refl. convoy e's

Reflected convoy electron damage?

- The brackets have been modified:
  - High-temperature material with low coeff. of thermal expansion (Ti)
  - Bracket material removed from path of convoy electrons (both arm and leg cut off)
  - All foils mounted at the “+1 cm” position
  - Improved mounting method to make better electrical contact
- Foils have been modified:
  - Longer free-standing length (was 25 mm, now 30 – 35 mm)
  - Some have longer corrugations with finer pitch (back to same 100 LPI pitch that was used for original 12 mm wide foils)
- Washer on chain saw pin will be stainless steel (no silver coated aluminum)
- There will also be one HBC foil, and one diamond foil mounted at an angle

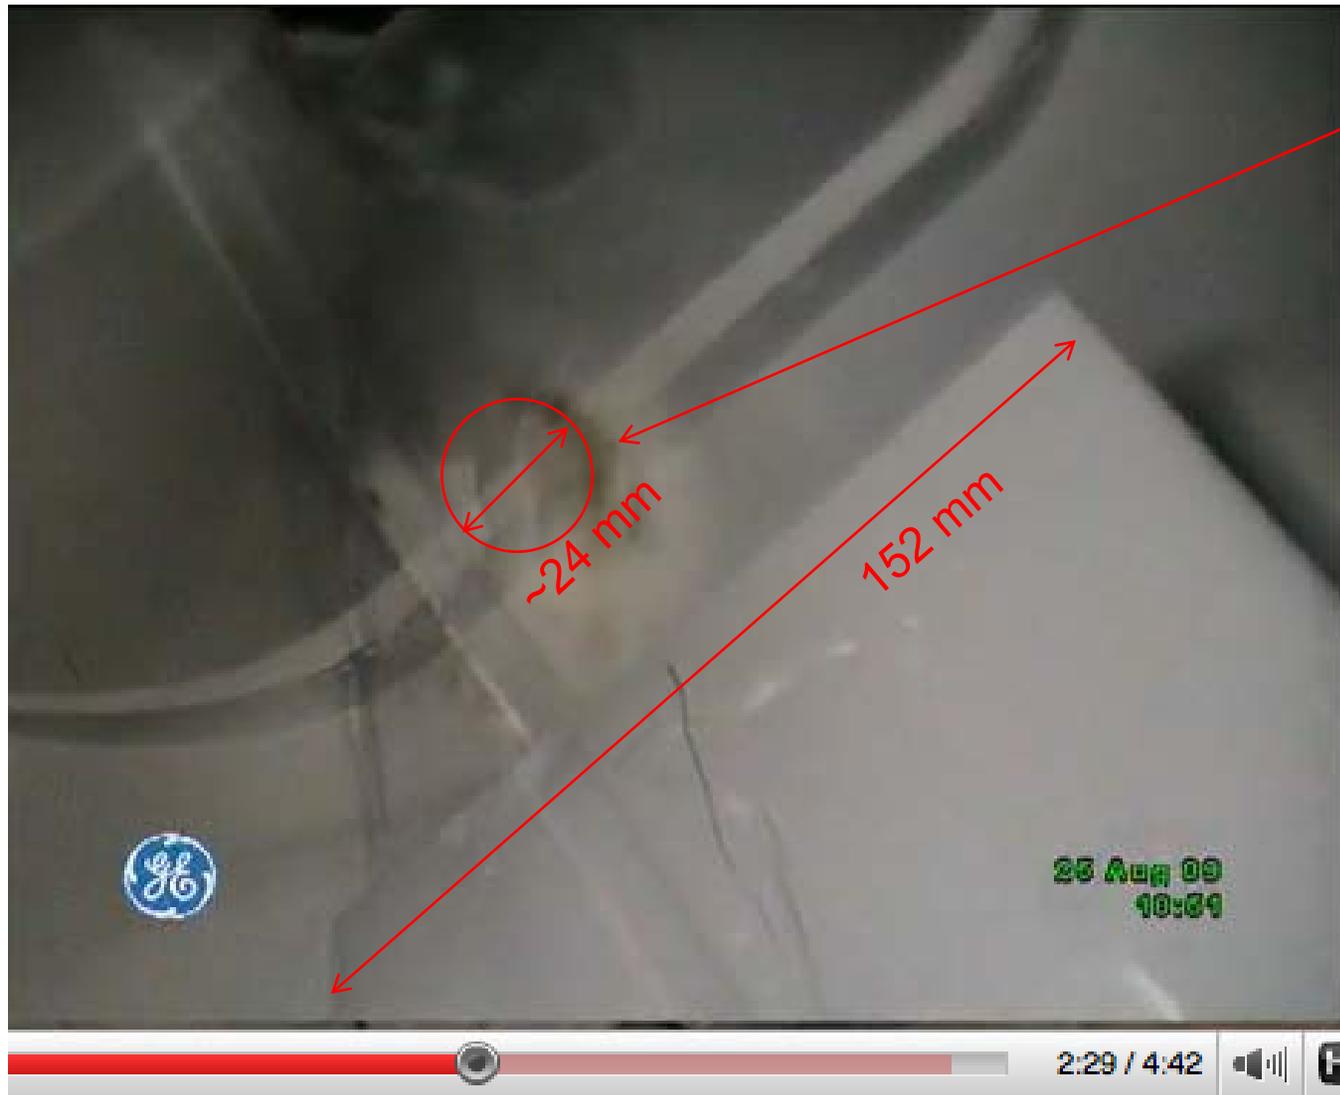
# Graphitization at top of vacuum chamber

Could be reflected  
convoy electrons  
or trailing-edge  
multipactoring

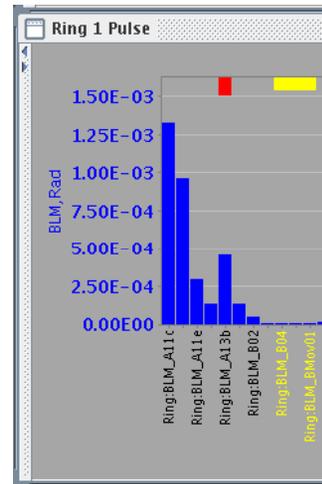
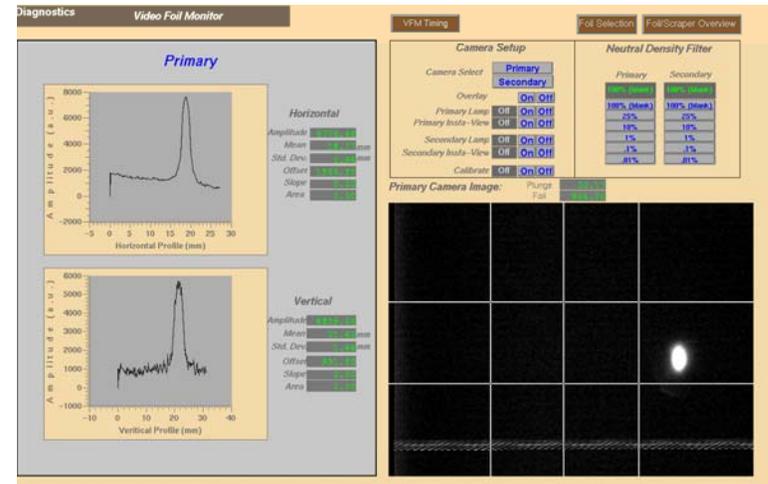
Typical spot up until ~May 3, 2009

May 1, 2009, 820 kW, 344 ug/cm<sup>2</sup>

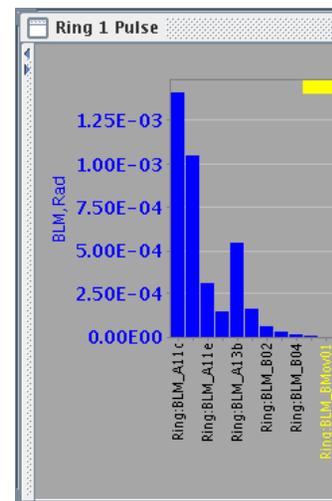
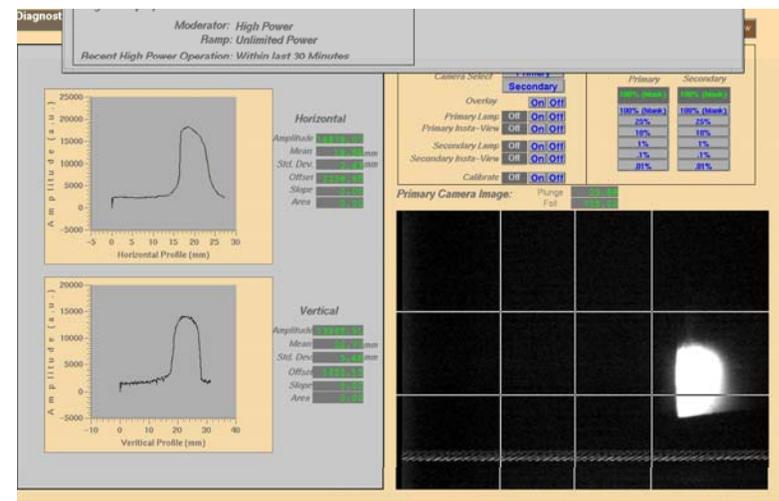
We believe that the brighter spot means higher foil temperature

May 3, 60 Hz, 9:38, ~840 kW, 386 ug/cm<sup>2</sup>

Foil failed shortly after

- We don't have a good explanation for the bright beam spots. Our best guess is that it is related to the aluminum deposited on the vacuum chamber walls. This could affect the reflected convoy electrons, the secondary emission electrons, and the trailing edge multipacting (all electron-related)
- The good news is that they seem to have returned to normal in the weeks following their first occurrence on May 3

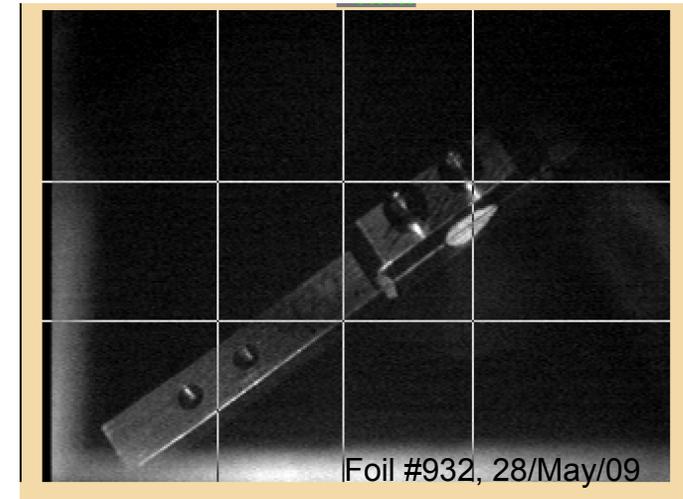
- This problem first showed up in fall 2008
  - Aluminum snap ring on same pin as bracket adhered to bracket by galling or melting
- Brackets redesigned and installed February 2009
  - But these had the counterweight and tab problem. Sticking would have been good in this case!
- 3<sup>rd</sup> generation brackets installed May 19, using silver plated aluminum washers
  - But this design also causes sticking / pinching
  - Best guess is that the silver plating on the washers de-laminates, and the washer effectively expands to pinch the bracket against the shoulder of the pin
- 4<sup>th</sup> gen, installed Aug. 31, 2009, has Ti brackets, stainless steel washers, no plating

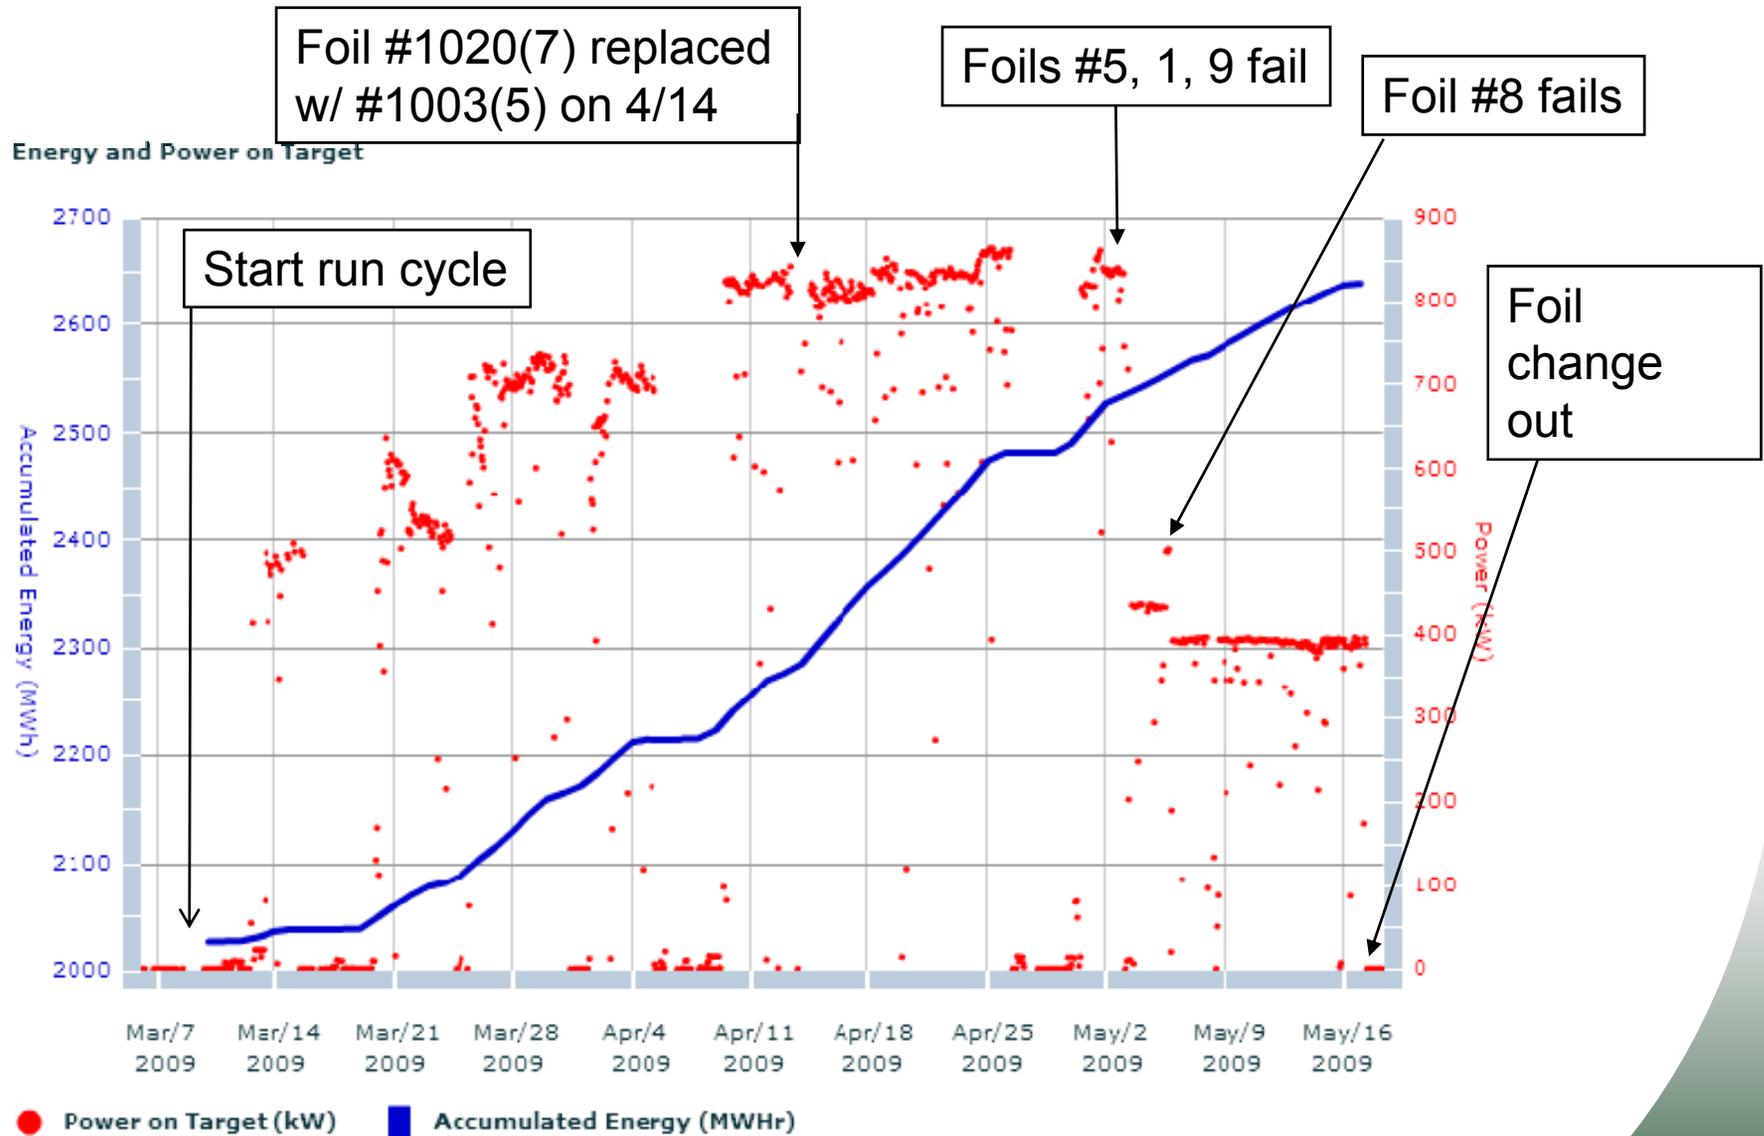
# Foil failure time line for first load

- Until the next foil load on May 19, all but one\*\* failure (the first) can be attributed to convoy electrons hitting the foil bracket, causing the counterweights to fall off. Vacuum chamber becomes coated with aluminum.

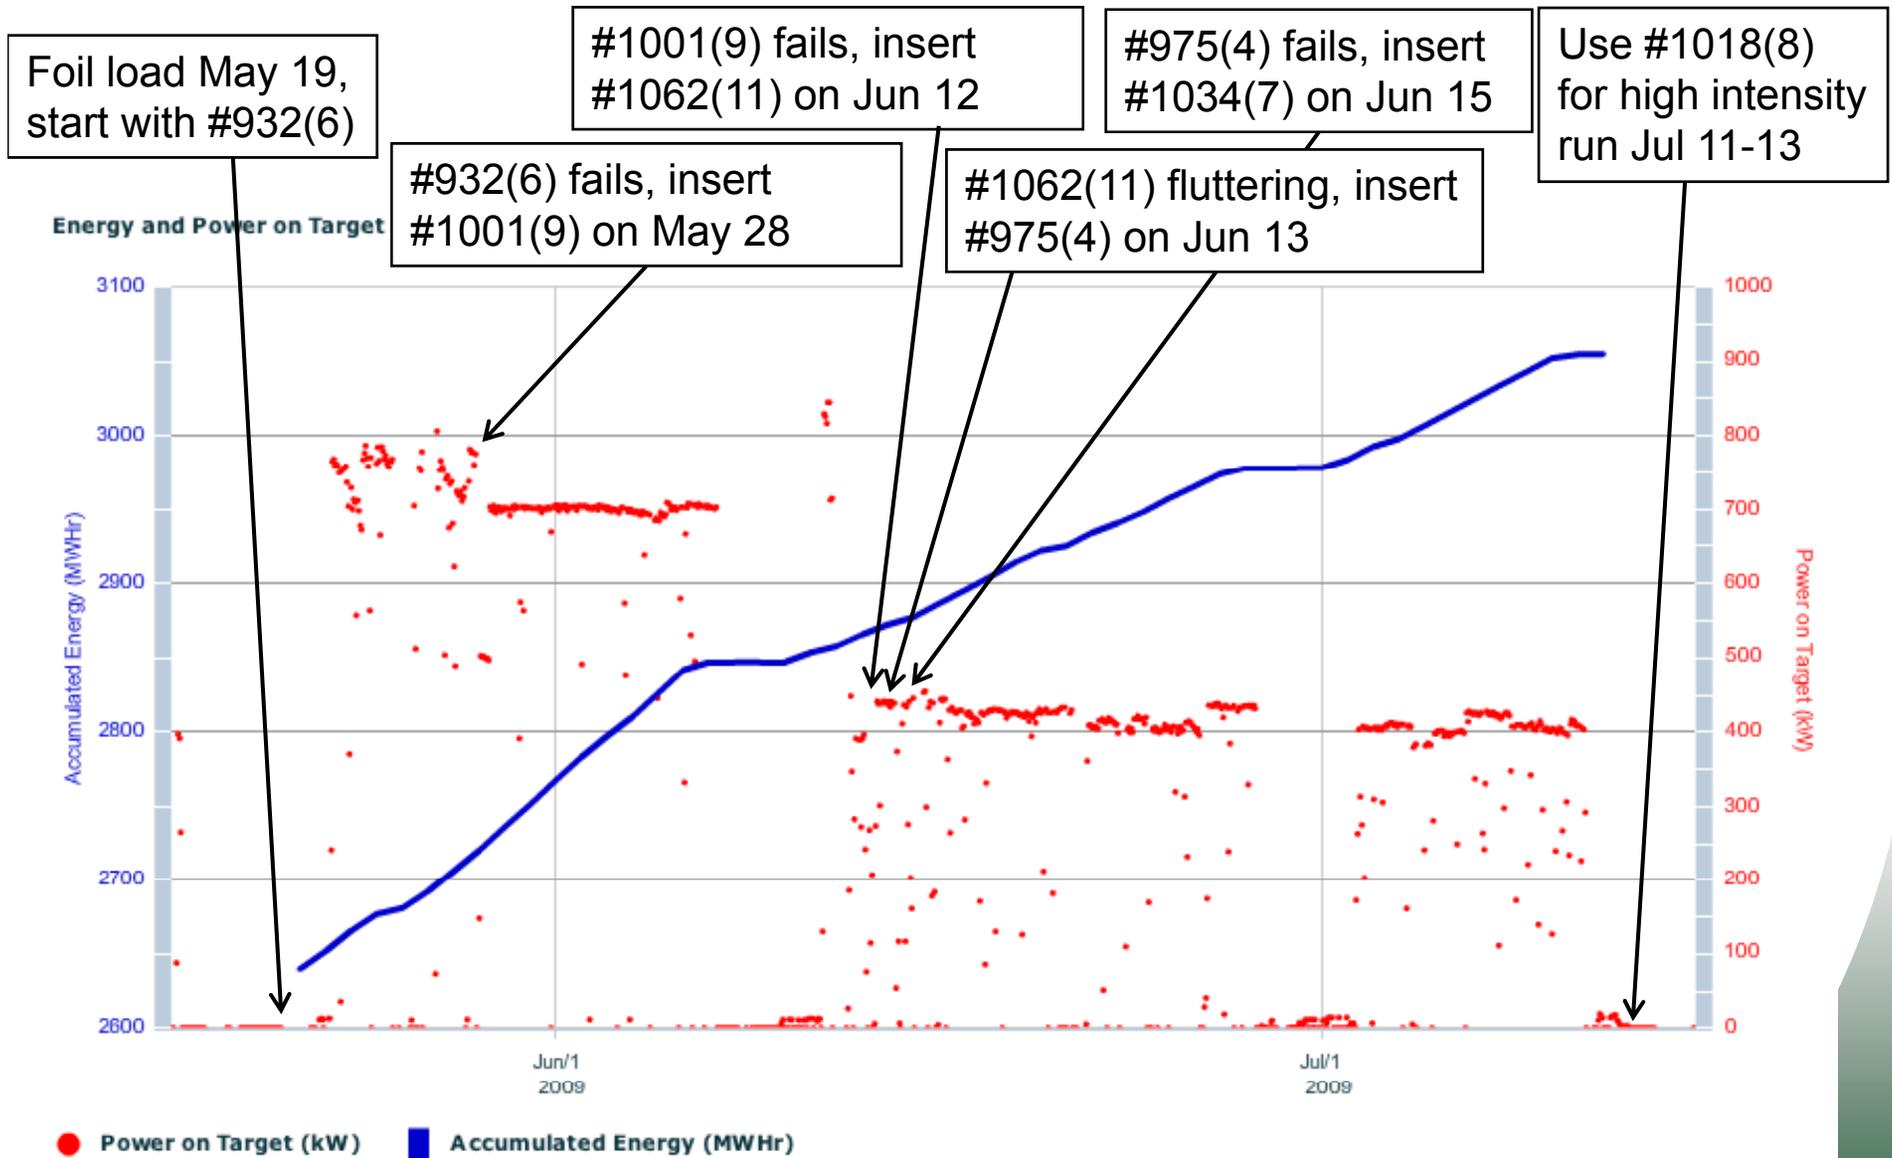
# Foil failures from second foil load

- On May 19, we installed a new batch of foils (first time for a mid-cycle foil change out). New foil brackets were used to fix the convoy electron issue. We returned to high power operations (~800 kW), but we saw two more foil failures. The beam power was reduced to ~400 kW for the rest of the run cycle.

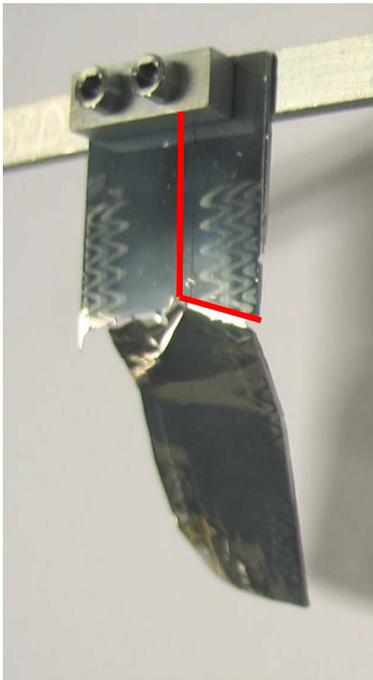
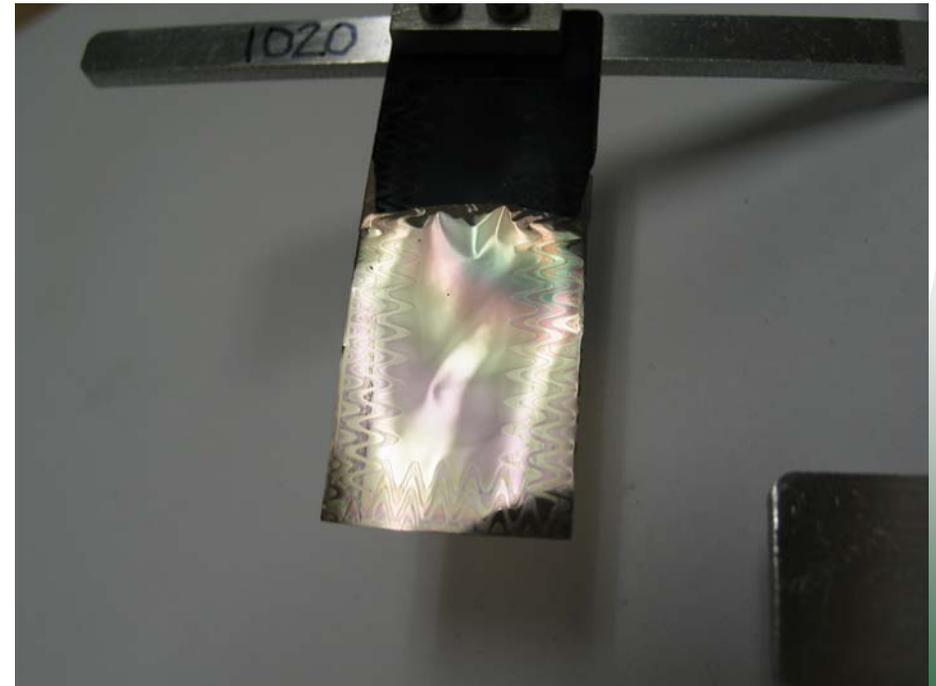
- Foil2.avi – spot moves 3 mm on camera
  - Corresponds to  $3/0.557 = 5.4$  mm foil movement
- Foil3.avi – spot moves 4 mm on camera
  - Corresponds to  $4/0.557 = 7.2$  mm foil movement
- This stripper foil, #1020, with “U sine” corrugations, was relatively floppy to start with. When removed, found that substrate was cracked and foil was partially separated from substrate. +/-3 mm is certainly possible.
