# SNS Ring injection experience

Project X collaboration meeting,  
FNAL, Sep 10-11, 2009

M. Plum,  
Ring Area Manager

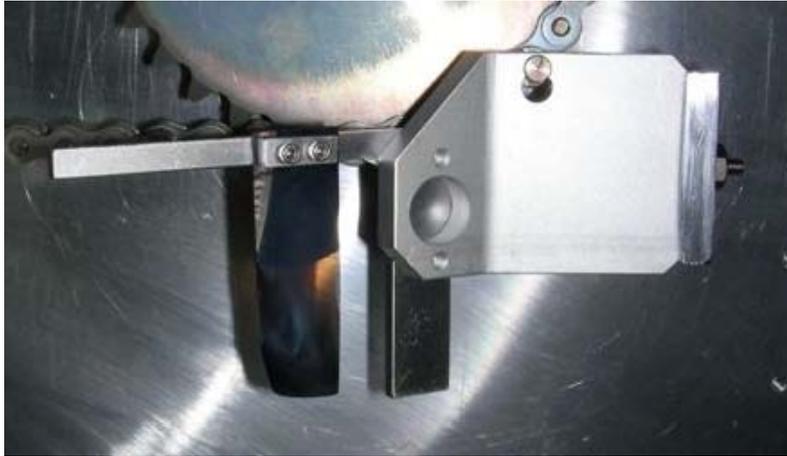
1<sup>st</sup> gen., used thru Jan/09  
Aluminum snap ring washer, 1/8 inch thick

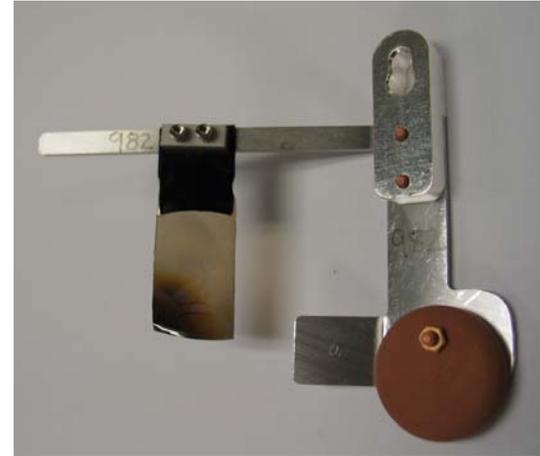
2<sup>nd</sup> gen., used Mar/09 – 17/May/09  
Silver plated "tombstone" hanger, ~0.080" thick

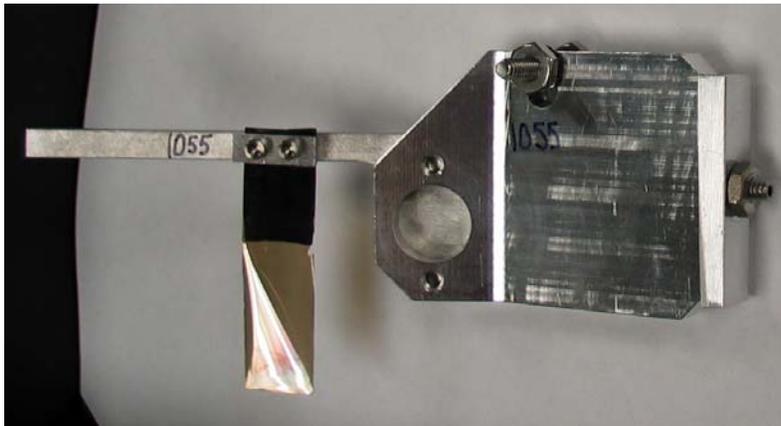
3<sup>rd</sup> gen., used 19/May/09 – 13/Jul/09  
Same original but has bottom cut off.  
Silver-plated aluminum washers.

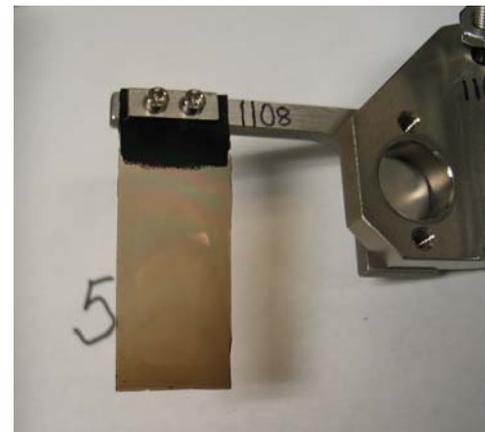
4<sup>th</sup> gen., used Sep/09 to present  
Ti bracket, SS washer, +1 cm position

Foils should be mounted >24 mm horizontally from the bracket. All new foils will be mounted at the “+1 cm” position. Also helps to use high temperature material for brackets.

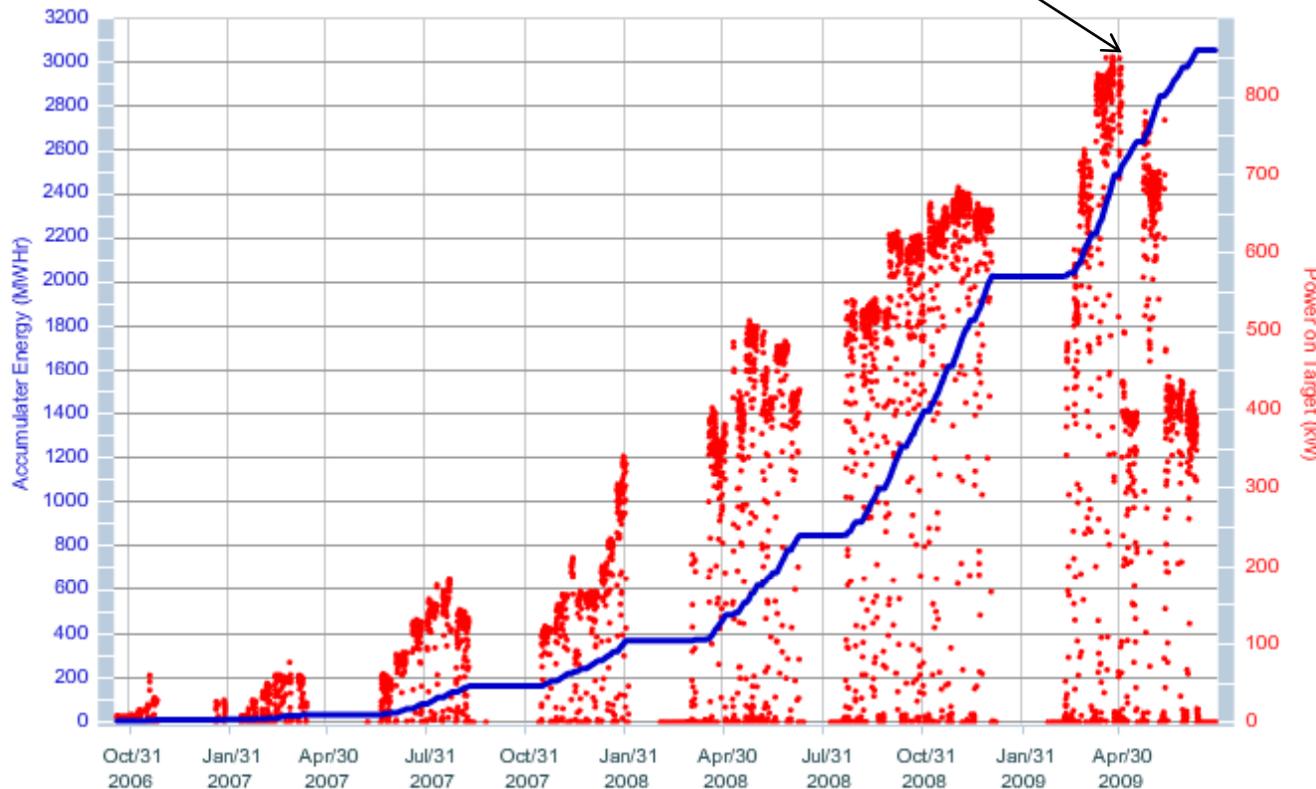
Power on Target

Until May 3, 2009, power ramp up was proceeding nicely and stripper foils were performing well. On May 3 we had our first foil failure.

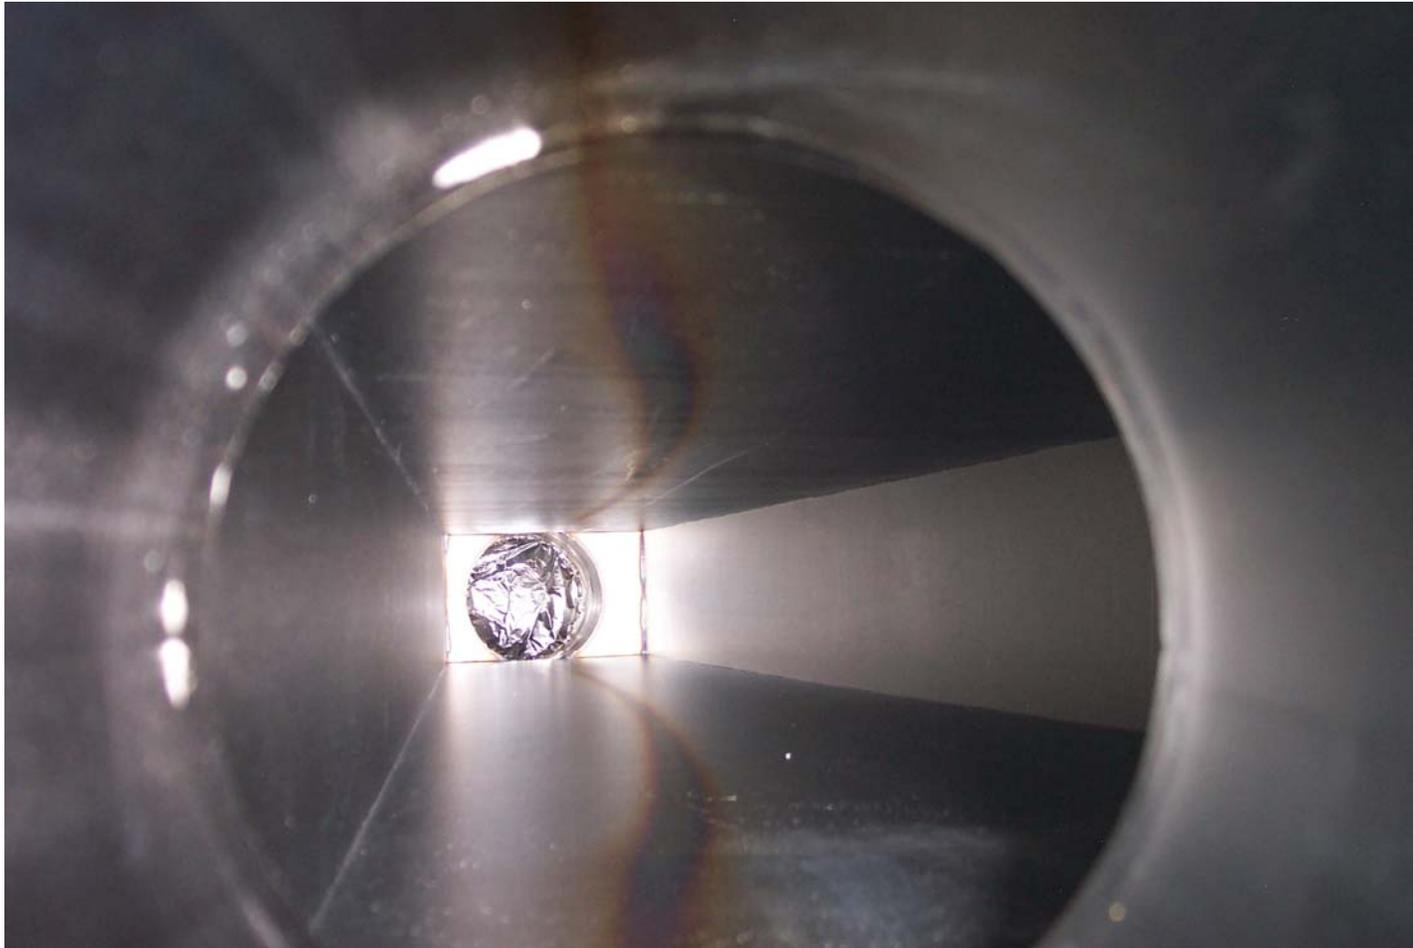
Example of graphitization by multipacting electrons in SRBM11 at PSR. This is not a thermal effect!

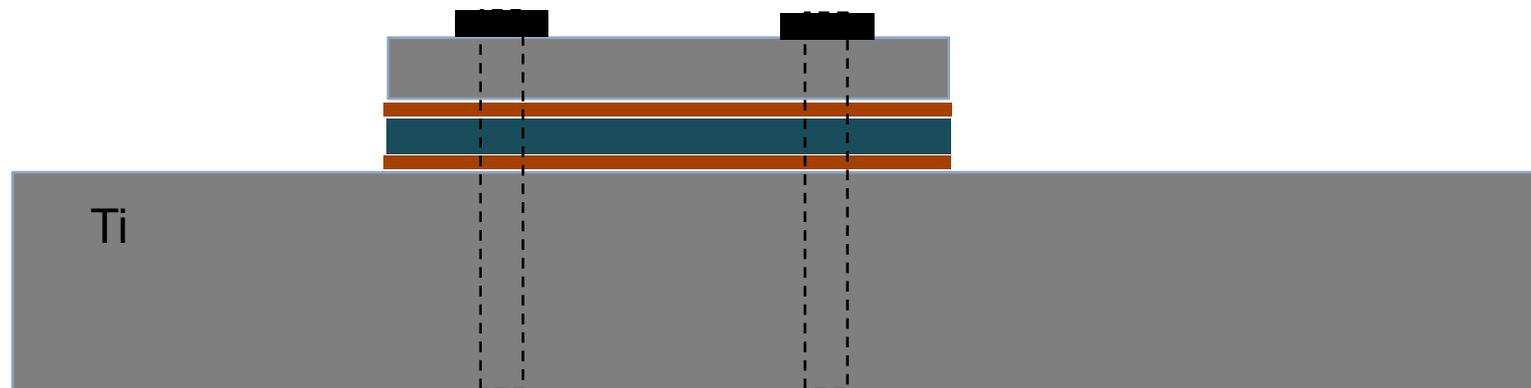
Sep – Dec run: about half the foils will be mounted using ~1.1 mil thick gold. No Belleville washers, no conductive adhesive. Brackets machined to a flatness spec then polished.

Foil mount for good electrical contact:

machine flat then polish bracket and clamp

sandwich Si substrate between thin sheets of Cu or Au (~0.001" thick)

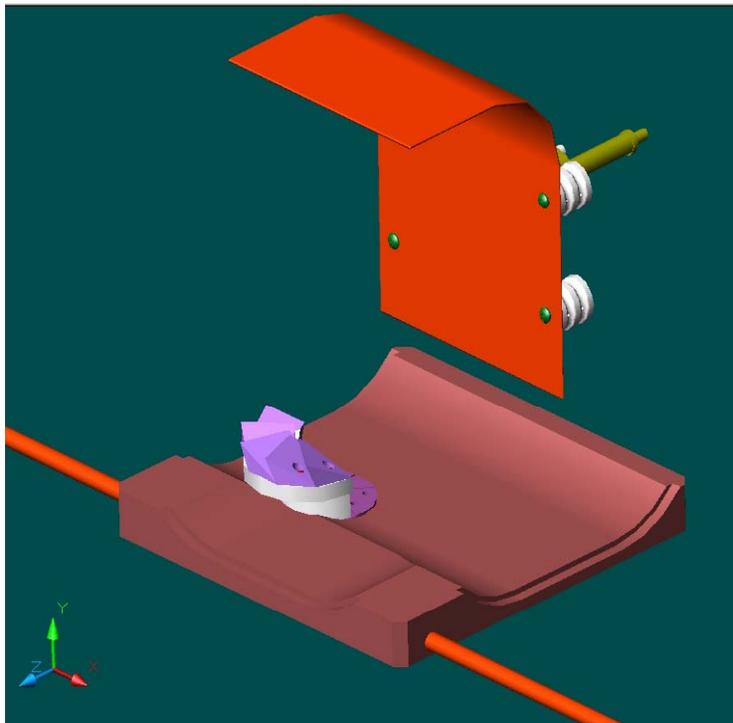
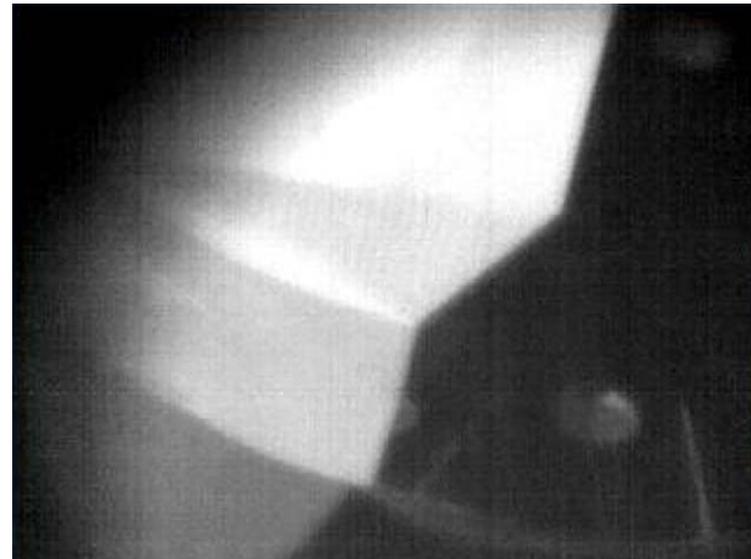
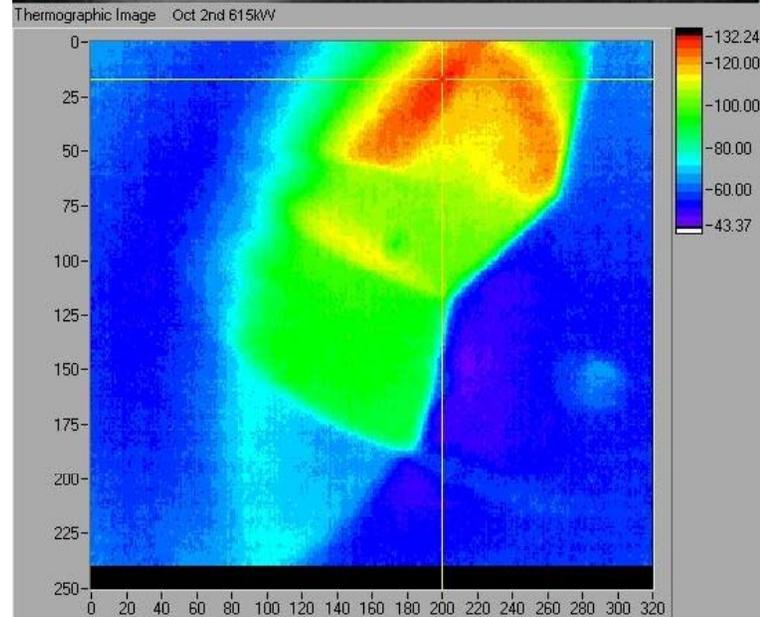
Measured the temperature of the carbon-carbon electron collector is 130 °C for 625 kW beam, (~12 °C lower than expected)

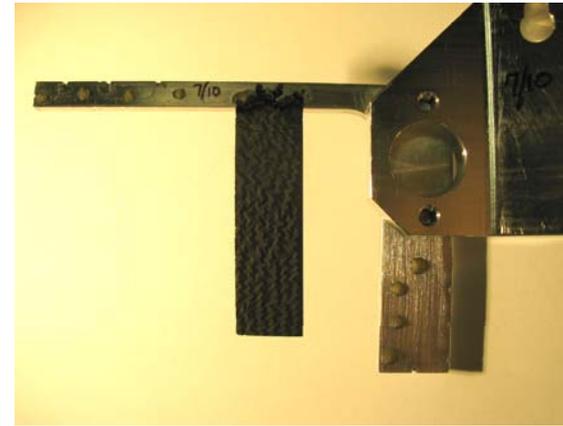
Special fiber supported foils  
Thin carbon fibers support the foil

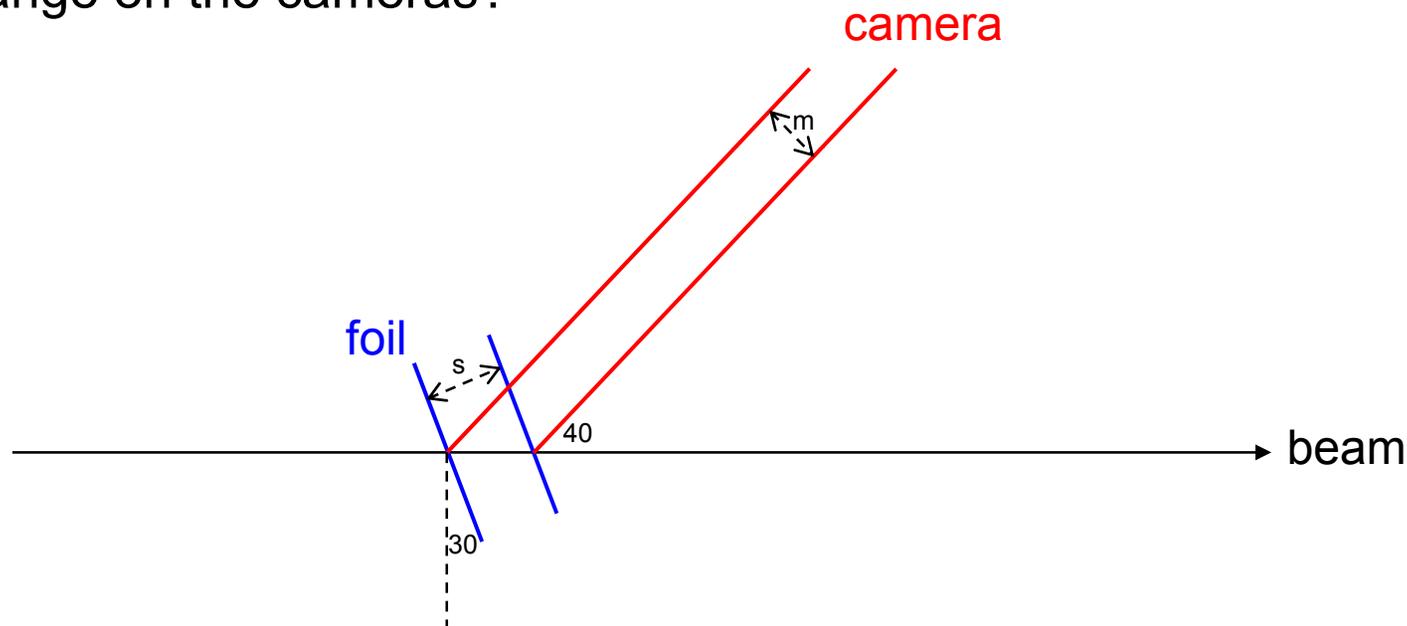
First time that more than tiny beam spot movements were observed was with foil #1020, used from March – April 14, 2009

- Foil2.avi – spot moves 3 mm on camera
  - Corresponds to  $3/0.557 = 5.4$  mm foil movement
- Foil3.avi – spot moves 4 mm on camera
  - Corresponds to  $4/0.557 = 7.2$  mm foil movement
- This stripper foil, #1020, with “U sine” corrugations, was relatively floppy to start with. When removed, found that substrate was cracked and foil was partially separated from substrate. +/-3 mm is certainly possible.
